Subject: Rear Spring Shackle Bolt Length
Models Years Affected: 2007 and beyond
Models Affected: Chevrolet Silverado
GMC Sierra
w/ZW9 or Pick Up Box Removal
Origination Date: September 7, 2016
Revision Date: N/A

ADVISORY:

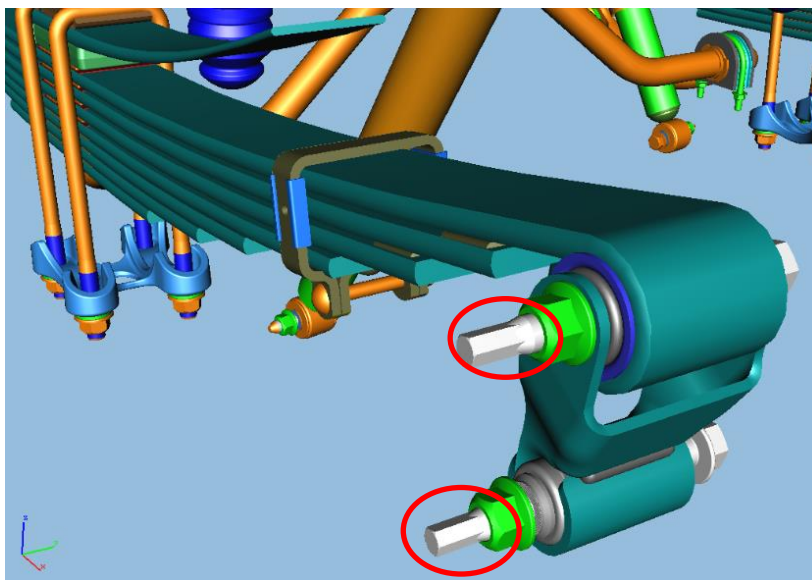
Upfitter/Service body and equipment installers have often expressed concerns regarding the “extra” length of the rear leaf spring shackle bolts interfering with the installation of the body or equipment.

The bolts for rear spring shackles have a hold & drive feature requirement for vehicle assembly. This feature adds extra length to the bolt required for the vehicle assembly process and cannot be eliminated.

IMPORTANT NOTICE: Body Builders/Upfitters can cut the extra length off this bolt, however they **MUST** maintain at least 3 threads **visible** on the end of the bolt after the joint is clamped.
